Manhole Inspection Summary

Manhole # S31UU1011MH

Location Address: **4 WYNDHURST AVE**

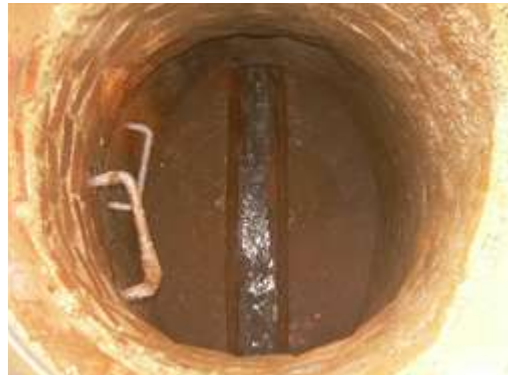
Top View

Corroded steps. Bench debris.

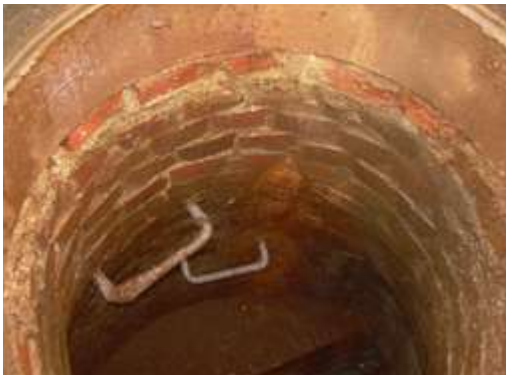
Defect

Frame leaks. Adjustment deterioration and infiltration. Barrel infiltration

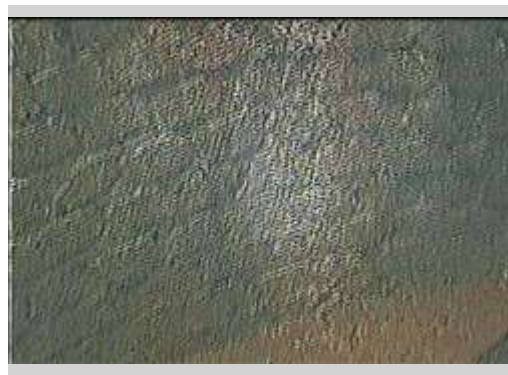
Defect

Barrel infiltration.

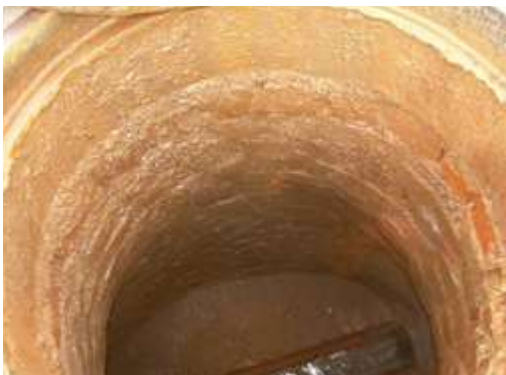
Defect

Frame leaks. Adjustment infiltration.

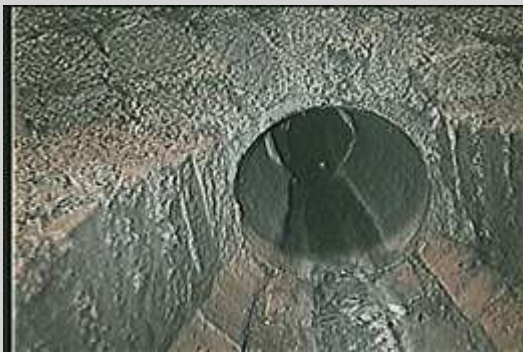
8 in. Circular Gravity Sewer Pipe Out @ 12 O'Clock

Invert Depth: **6.48** (ft.) Flow Characteristics: **Slow**

Deposits: ☒ None ☐ **Mud** ☐ Sludge ☐ Debris ☐ **Grease**

Infiltration: **None** Pipe Seal Cond: **Unknown**

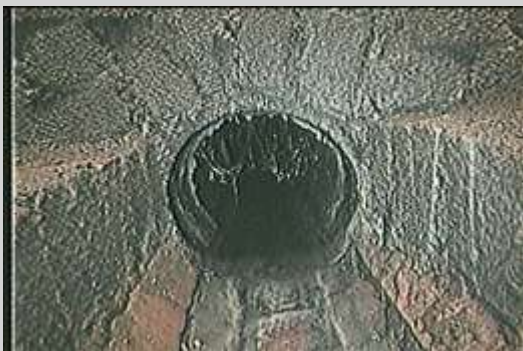
8 in. Circular Gravity Sewer Pipe In @ 6 O'Clock

Invert Depth: **6.35** (ft.) Flow Characteristics: **Slow**

Deposits: ☐ None ☒ **Mud** ☐ Sludge ☐ Debris ☒ **Grease**

Silt Depth: **0** (in.) Deposits Extent: **Light**

Infiltration: **None** Pipe Seal Cond: **Unknown**
